New York State Department of Transportation

Yellow Flag NB22CTW018

BIN: 1065318

Feature Carried: 278I278IX2M23027

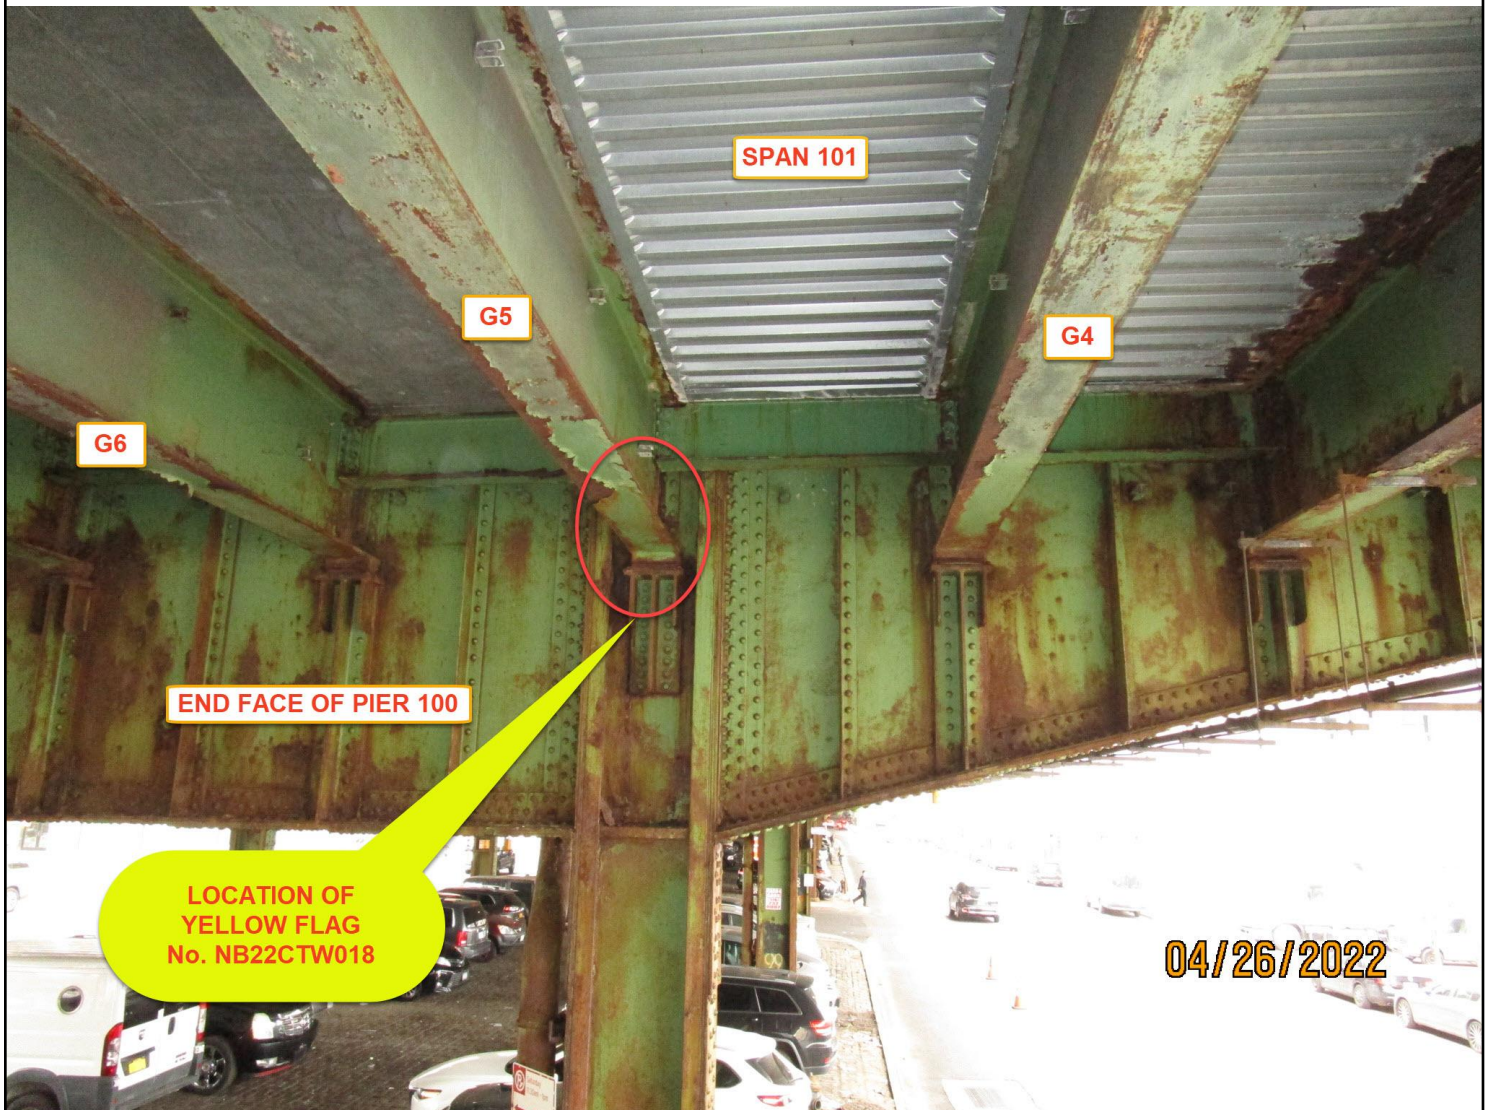
Photo Number: 1

Description: The end of Girder G5 in Span 101 at Pier 100 exhibits severe corrosion resulting in an overall web bearing area section loss of approximately 41% and an overall shear web area section loss of approximately 48% with an average overall localized section loss of approximately 51% for 6"L x 8"H area directly above the bearing below the guide angle. Also, the lower web of the girder adjacent to the web bearing area exhibits average 30% section loss for 2'L x 4"-7"H above the bottom flange. In addition, the bottom flange adjacent to the bearing exhibits 50% edge section loss at both sides for 2'L x 3"W. (Refer to sketch for more details). These conditions are the same as reported in the last inspection.

Attachment Description: General view of the flag location at Girder G5 in Span 101 at Pier 100. Looking Begin.

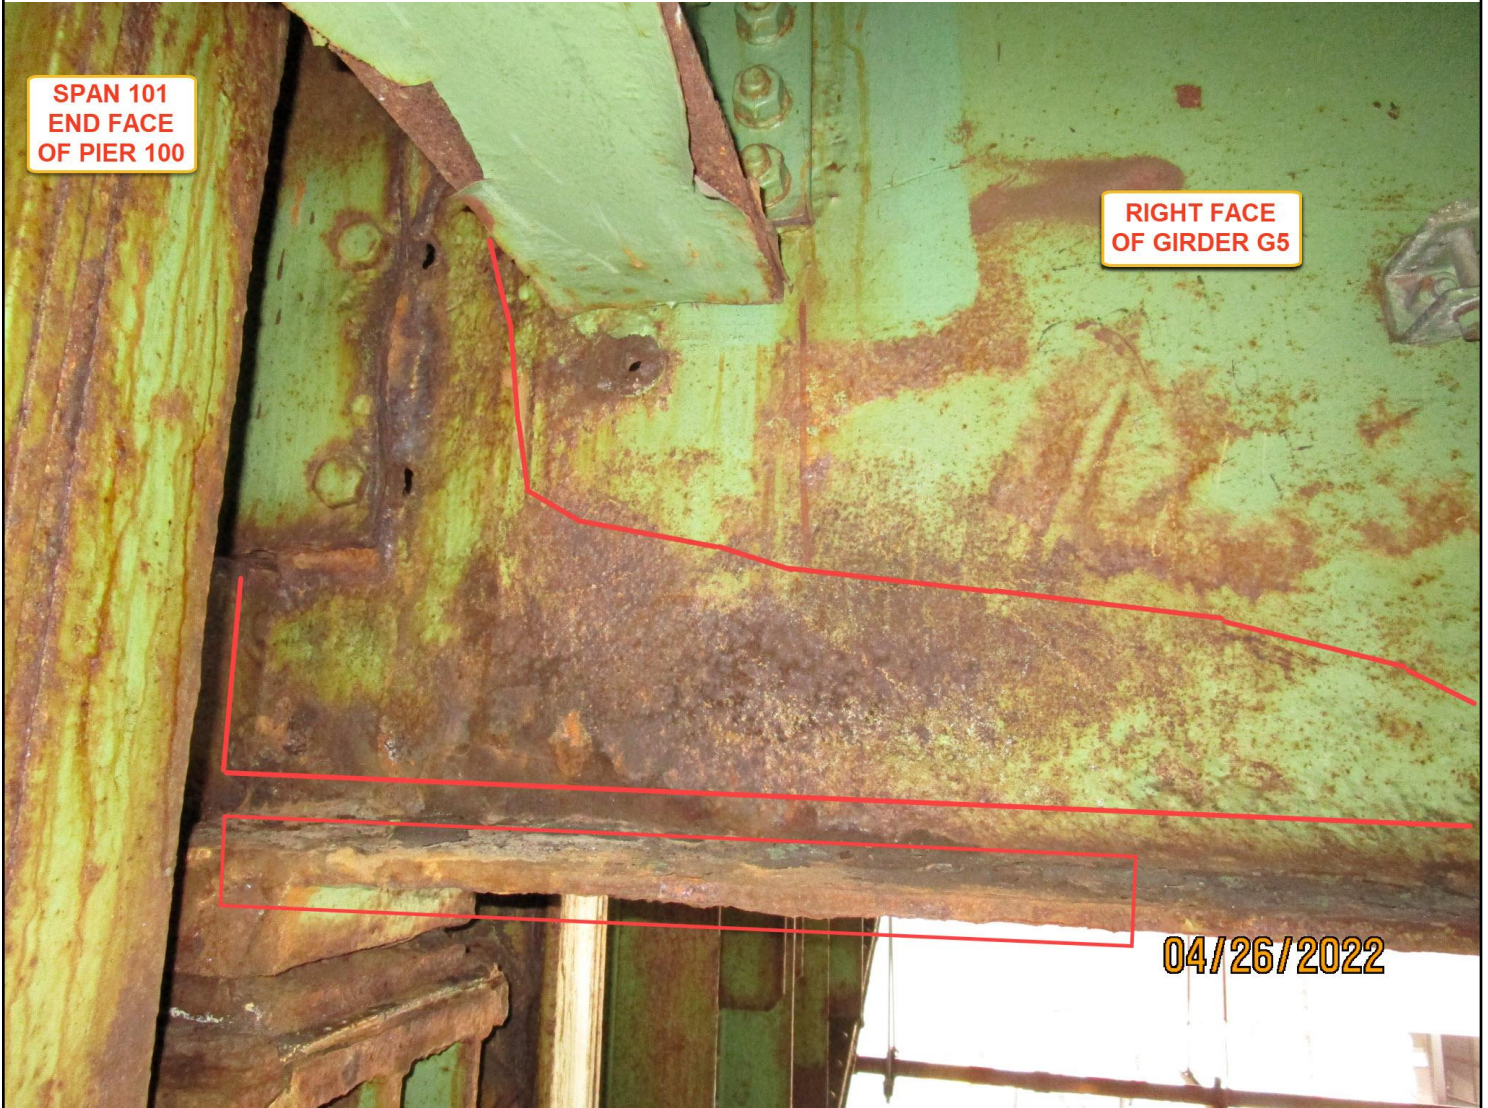
Photo Number: 2

Attachment Description: The Right Face of Girder G5 in Span 101 at Pier 100. The end of the girder exhibits severe section loss at the lower web above the bottom flange and web height adjacent to the guide angle with section loss at the bottom flange. Looking Left.

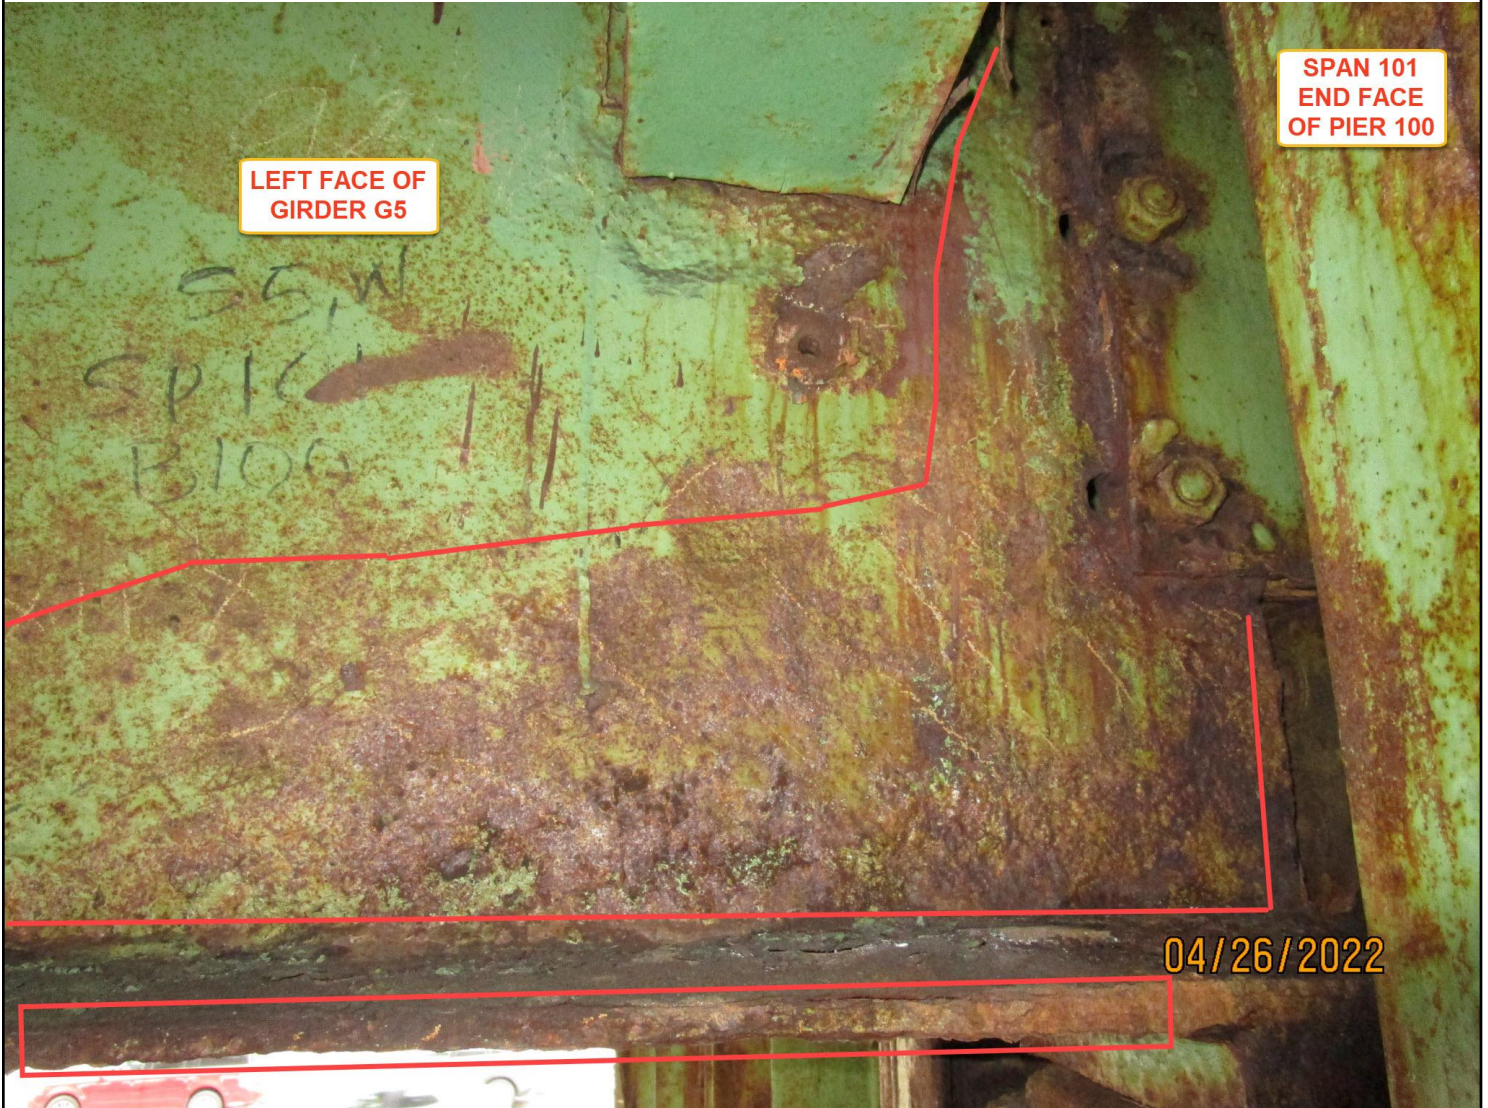
Photo Number: 3

Attachment Description: The Left Face of Girder G5 in Span 101 at Pier 100. The end of the girder exhibits severe section loss at the lower web above the bottom flange and web height adjacent to the guide angle with section loss at the bottom flange. Looking Right.

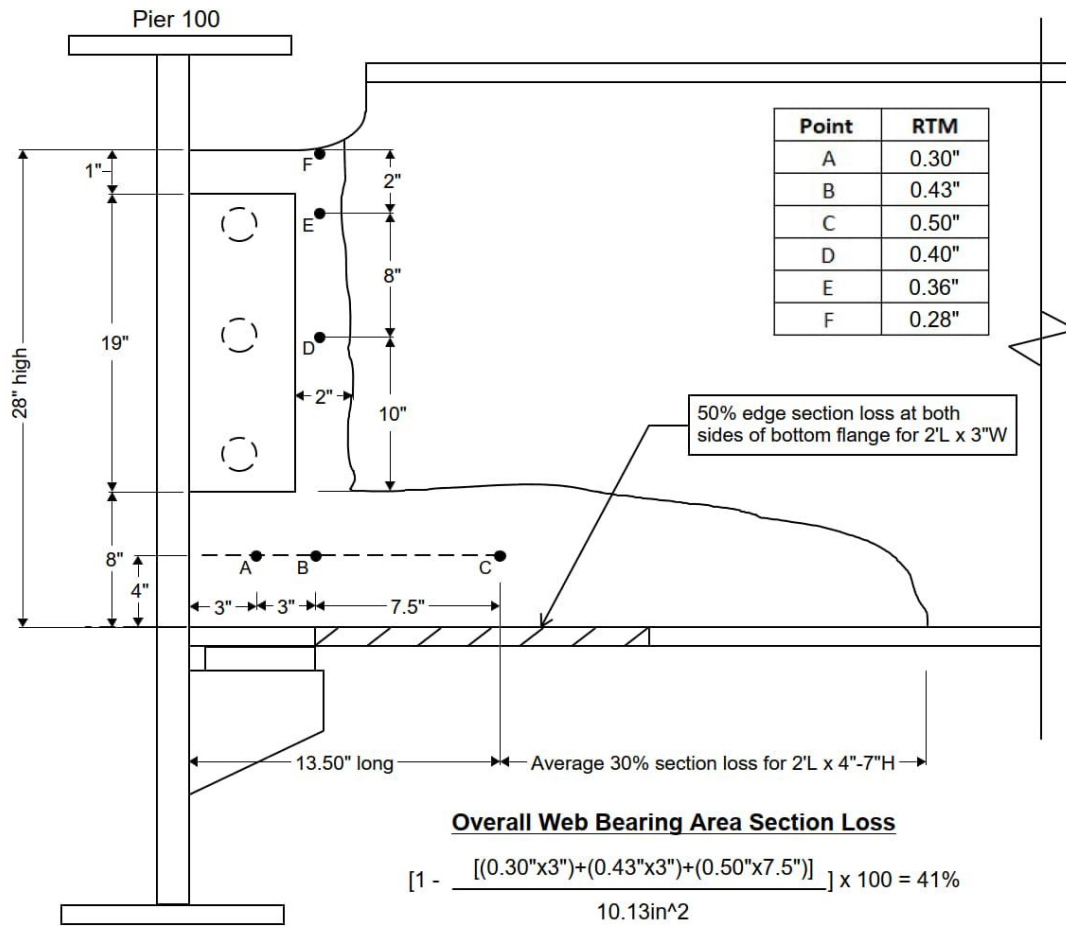
Right Face of Girder G5 Sketch in Span 101 at Pier 100

**Overall Web Bearing Area Section Loss**

$$\left[1 - \frac{[(0.30" \times 3") + (0.43" \times 3") + (0.50" \times 7.5")]}{10.13 \text{ in}^2} \right] \times 100 = 41\%$$

Overall Shear Web Area Section Loss

$$\left[1 - \frac{[(0.43" \times 8") + (0.40" \times 10") + (0.36" \times 8") + (0.28" \times 2")]}{21 \text{ in}^2} \right] \times 100 = 48\%$$

- As-built web thickness = 0.75"
- Length of bearing area = 18 x web thickness = 18 x 0.75" = 13.50"
- Overall bearing area = 13.50" x 0.75" = 10.13 in²
- As-built shearing web area = 28" x 0.75" = 21 in²
- Adjacent Girder G4 exhibits up to 35% section loss in the lower web above the bottom flange and 25% section loss for the full height of the web adjacent to the guide angle. Also, the bottom flange exhibits 25% section loss in the bottom flange.
- Adjacent Girder G6 exhibits average 42% localized section loss in the lower web above the bearing area with up to 35% section loss in the lower web for 4' long area adjacent to the bearing and up to 30% section loss for the full height of the web adjacent to the guide angle.
